Paper

Evaluation of the Ni Diffusion to the Surface of Au Plating for Soldering Process Control

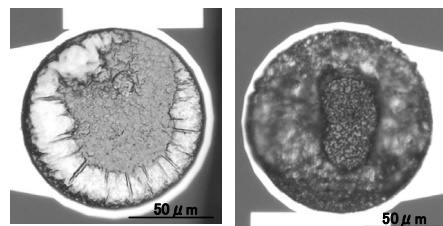
Fig.1 Optical micrographs of poor solder wetting electrodes.

Fig.1 shows the optical micrographs of the disassembled electrodes of the soldering failure samples. The solder do not wet at the center. By empirical knowledge on failure analysis, we can suspect that the causes are foreign particles, contaminations, and/or Ni oxide film formation on the surface.

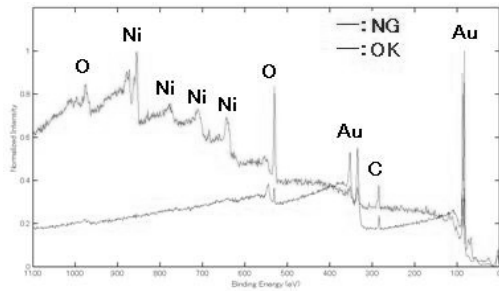
XPS measurements were performed on two Au electrode samples before soldering. One sample was taken from the solder wetting defective production lot (NG-lot sample), the other was from the normal production lot (OK-lot sample). Fig.2 shows the XPS survey spectra of the two sample surfaces. Ni and O peak intensities of the NG-lot sample are stronger than those of the OK-lot sample. Fig.3 shows Ni 2p spectrum of the NG-lot sample. The peak at 855 eV in

Fig.2 XPS survey scan spectra of NG-lot sample and OK-lot sample.

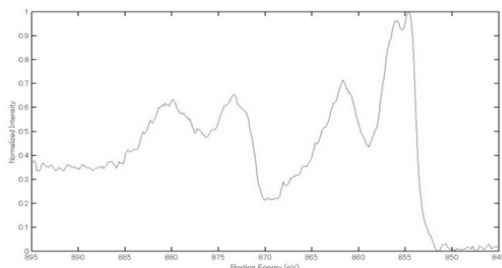
Fig.3 Ni2p spectrum of the NG-lot sample.

binding energy is attributed to Ni oxide. Fig.4 shows the depth profile of NG-lot sample. In this depth profile, Ni and O layer are on top of the Au layer. These results indicate that Ni oxide film is formed on the Au electrode of the NG-lot sample. Accordingly, the cause of the poor solder wetting is concluded to be the diffusion of the Ni to the Au electrode surface from the underlayer, and the formation of the Ni oxide film as illustrated in Fig.5.

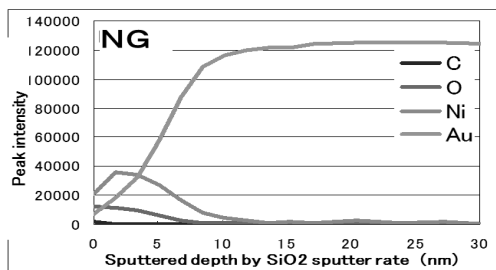
Fig.4 Depth profile of the NG-lot sample.

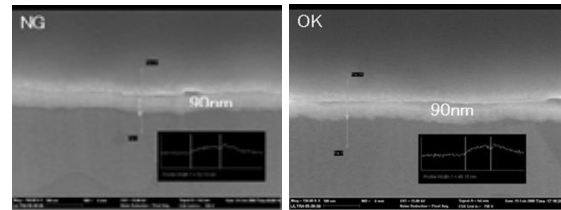
Fig.6 The cross-section SEM images.

The thicknesses of the Au film of NG-lot and OK-lot samples were estimated by cross-section view of SEM. The cross-section of the electrodes was processed with focused ion beam. Fig.6 shows SEM images of the cross-section. The bright parts, middle of the image, are Au films. The Au film thicknesses of these samples are almost same, about 90 nm. There are no differences between NG-lot sample and OK-lot sample.

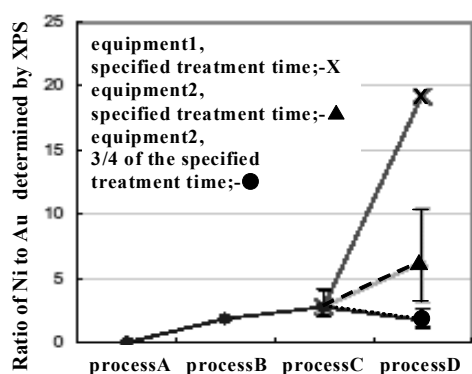
For evaluating the second reason, XPS measurements were conducted for the four processes after Au film deposition, namely processes A, B, C, and D, in order to determine surface atomic compositions. From XPS quantification results, the atomic concentration ratios of Ni to Au of the electrode were calculated and plotted against the process as shown in Fig.7. The solid, dashed, dotted lines correspond to the samples in process D from equipment 1, from equipment 2, and from equipment 2 for short time (0.75 times to the other sample), respectively. Equipments 1 and 2 carried out the same process treatment but

equipment 2 started in operation later. The ratio of Ni to Au determined by XPS ($\text{Ni}/\text{Au}_{\text{XPS}}$) corresponding to the amount of Ni diffused to the surface of Au, tends to increase in process D. Particularly, the solid line showed drastic increase which indicates that the Ni atoms diffuse into Au and segregated on the Au surface using equipment 1 in process D. The occurrence of poor solder wetting using equipment 1 is higher than those of others, which suggests that the ratio of Au to Ni on the electrode surface are correlated with the poor solder wetting. Additionally, the ratio of Au to Ni decreases by shortening the treatment time in process D (dashed line and dotted line).

Fig.7 Atomic concentration ratio Ni/Au of the electrodes.

These results mean found that Ni diffusion to the Au surface is promoted in process D, especially in the treatment with equipment 1, it results more frequent poor solder wetting than that with equipment 2. Therefore, we introduced two countermeasures in process D. (1) Review of the treatment condition with equipment 1. (2) Introduction of the evaluation of Ni diffusion to the Au surface (the Ni/Au ratio) after process D as for the lot process control.

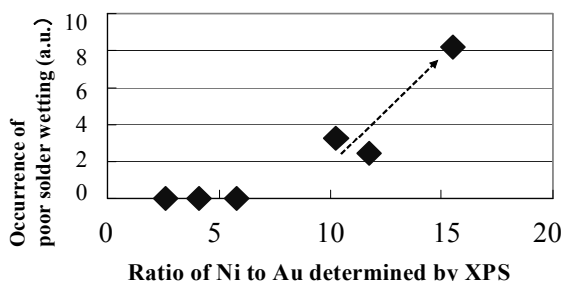
Fig.8 Relation of the atomic concentration ratio Ni/Au and the occurrence of poor solder-wetting.

For obtaining different occurrence of poor solder wetting, the electrode forming process was changed, then the atomic composition of prepared samples were evaluated with XPS. Fig.8 shows the relation of ($\text{Ni}/\text{Au}_{\text{XPS}}$) and the occurrence of poor solder wetting. When ($\text{Ni}/\text{Au}_{\text{XPS}}$) is higher than about 10, the occurrence of poor solder wetting increases. Thus, the high occurrence lot of poor solder wetting can be monitored by measuring ($\text{Ni}/\text{Au}_{\text{XPS}}$) of production lot, which can also be applied to the lot process control.

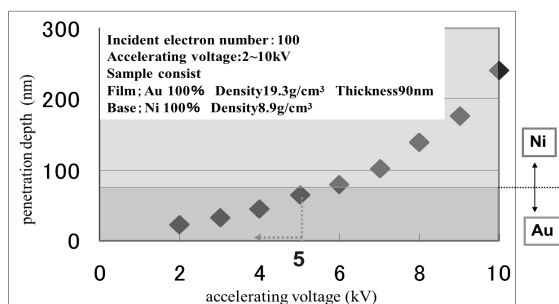
- The information depth should be few tens nm for satisfying the previous mentioned requirement (a).
- The acceleration voltage can excite $\text{NiL}\alpha$ line (0.85 keV) and $\text{AuM}\alpha$ line (2.12 keV) at more than 3 kV. We estimated the electron penetration depths into the sample by Monte Carlo simulation. The model sample structure was a 90 nm thick Au film on Ni substrate. The density of the Au film was assumed to be that of bulky Au. Fig.9 shows the result.

The electron penetration depths at the acceleration voltage of 3 kV, 5 kV are approximately 30 nm and 90 nm, respectively and the electron penetration depths at 5 kV is similar to the Au film thickness. However, the actual sample was a deposited film, suggesting that the

Fig.9 Electron penetration depth into the sample by Monte Carlo simulation at an acceleration voltage of 2-10 kV.

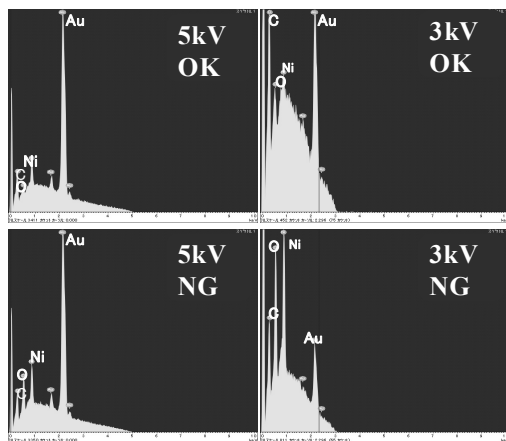
It is suspected that the suitable range of acceleration voltage is 3 to 5 kV. Analysis of NG-lot samples and OK-lot samples were performed using SEM-EDX. The spectral analysis was performed at the acceleration voltages of 3 and 5 kV. Fig.10 shows the SEM-EDX spectra. The aperture diameter of electron gun was 60 μm and the measurement time was 60 seconds. Almost equal intensities of the Ni peak are

obtained in both NG-lot samples and OK-lot samples. A clear difference is not observed between NG-lot and OK-lot at the acceleration voltage of 5 kV. On the other hand, at the acceleration voltage of 3 kV, strong peaks of Ni and O are detected from NG-lot samples; but very weak peaks of Ni and O are detected from OK-lot samples.

Fig.10 SEM-EDX measurement spectrum at the acceleration voltage of 3 kV, 5 kV with 60 μm aperture diameter.

deposited film density was smaller than the bulk density. Therefore, it is considered that the Ni underlayer is detected at the acceleration voltage of 5 kV, and that Ni on the Au film is only detected at the acceleration voltage of 3 kV. Fig.11 shows the observed SEM-EDX spectra at 3 kV acceleration voltage with 30 μm aperture diameter. This aperture parameter is the same that is used for SEM observation. The measurement time was 60 seconds. Compared to the spectra of Fig.10, the sensitivity is much lower, which explain the difficulty to detect the small amount of Ni.

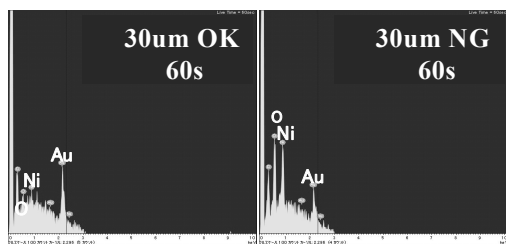
Fig.11 SEM-EDX measurement spectrum at the acceleration voltage of 3 kV with 30 μm aperture diameter.

From these results, the measurement condition was determined as the acceleration voltage 3 kV, the aperture diameter 60 μm, and the measurement time 60 seconds. In these experimental conditions, the results of SEM-EDX showed the occurrence of poor solder wetting tends to increase when (Ni/Au_{XPS}) is higher than about 10. If there is a correlation between the intensity ratio Ni/Au with SEM-EDX (Ni/Au_{SEM-EDX}) and (Ni/Au_{XPS}), the evaluation of Ni diffusion to the Au surface with SEM-EDX can be applied to the process control.

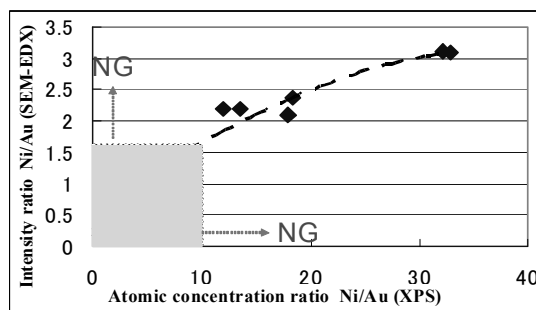
Then, some samples that were picked up from the lots showing the occurrence of poor solder wetting were analyzed by both XPS and SEM-EDX. Fig.12 shows (Ni/Au_{SEM-EDX}) as a function of (Ni/Au_{XPS}) which suggested the correlation between (Ni/Au_{SEM-EDX}) and (Ni/Au_{XPS}). When (Ni/Au_{XPS}) is higher than 10, (Ni/Au_{SEM-EDX}) is higher than about 1.5. Those results suggest that the evaluation of Ni diffusion to the Au surface is possible by using with SEM-EDX at low acceleration voltage

Fig.12 Correlation between (Ni/Au_{SEM-EDX}) and (Ni/Au_{XPS}).

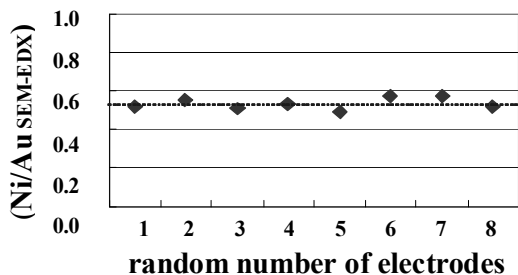
Fig.13 The variation among electrodes in a chip.

Fig.13 shows the $(Ni/Au)_{SEM-EDX}$ by the random number of electrodes (Test1). The mean value of $(Ni/Au)_{SEM-EDX}$ was 0.53 and the standard deviation σ was 0.032. All of the measured values of the electrodes in a chip were in $\pm 3\sigma$, therefore, it suggested that $(Ni/Au)_{SEM-EDX}$ was independent of the electrode position in a chip. Hence, test2 was carried out with the electrode at the center position in a chip.

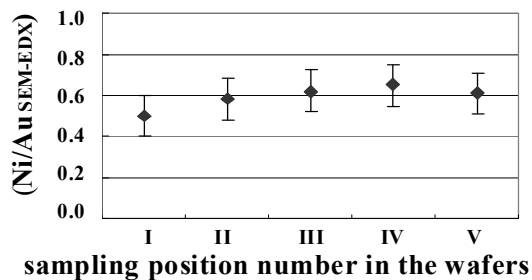
On the test2, five chip samples were picked up from five points of a wafer as shown in Fig.14, and three wafers were evaluated. Fig.15 shows the mean value of $(Ni/Au)_{SEM-EDX}$ of 3 wafers measured at each position (I to V). The mean value of $(Ni/Au)_{SEM-EDX}$ for all positions was 0.59, and the standard deviation σ was 0.075. $(Ni/Au)_{SEM-EDX}$ at position I (center position) tended to be lower than those at position II to V (peripheral position), however, all the measured values

Fig.15 The variation among chips in a wafer.

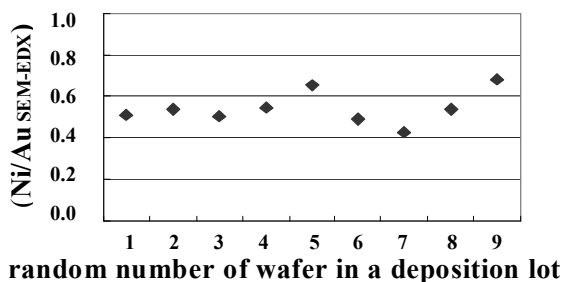
Fig.16 The variation among wafers in a film deposition lot.

On the test3, chip samples were picked up from the center position (position I) of 9 wafers in a deposition lot. Fig.16 shows the $(Ni/Au)_{SEM-EDX}$ by the random- wafer- number in a deposition lot. The mean value of $(Ni/Au)_{SEM-EDX}$ was 0.54, and the standard deviation σ was 0.079. In a deposition lot, all measurement values were within $\pm 3\sigma$.
