# Effects of Carbon Contaminations on Electron-Induced Damage of SiO<sub>2</sub> Film Surface at Different Electron Primary Energies

Dependence of the electron-induced damage of the clean and carbon-contaminated SiO<sub>2</sub> film surfaces during the Auger electron spectroscopy measurement was investigated under irradiation of electrons at different primary energies. The variation in the intensity of the Si-LVV elemental peak with the increase in the electron dose was measured and analyzed within the scheme of the two-step decomposition model [*J. Surf. Sci. Soc. Jpn.* **25**, 212 (2004) (*in Japanese*)]. The results clearly revealed that the rate of the decomposition of SiO<sub>2</sub> induced by the electron irradiation is decreased by a small amount of carbon contaminations of ~0.03 nm thickness on the SiO<sub>2</sub> surface. The effects of carbon contaminations on the reduction in the electron-induced degradation of SiO<sub>2</sub> is significant for the low-primary energy of electrons of 3 keV, and no effects were confirmed at the primary energy of 15 keV. These findings suggest that the primary energy dependence is attributed to the fact that interactions between primary

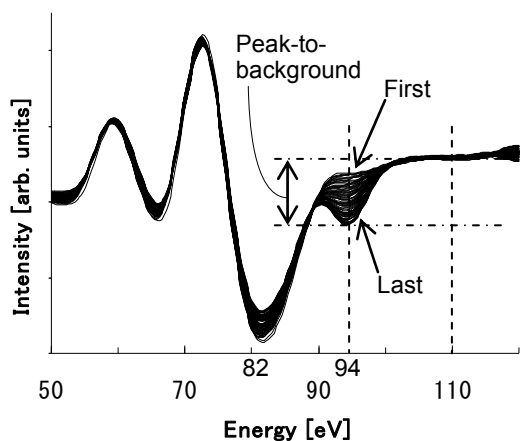
Figure 2 shows typical Si-LVV AES spectra obtained during the SiO<sub>2</sub> film surface being damaged under the electron irradiation. The peak at approximately 82 eV corresponds to SiO<sub>2</sub>. With the increase in the electron dose, the intensity of the peak at 94 eV due to elemental Si increases. In the analysis described below, the changes in the elemental Si peak intensities determined as the peak-to-background, where the background intensity was deduced from the intensity at 110 eV, were discussed.

Fig. 2. Changes in the Si-LVV peak from the SiO<sub>2</sub> film surface with the increase in the electron dose. The primary energy of electrons was 3 keV. The dose rate was  $4.7 \times 10^{-4}$  C/cm<sup>2</sup>s. The total dose was 5.7 C/cm<sup>2</sup>. The electron dose during the measurement of one AES spectrum was  $7.1 \times 10^{-2}$  C/cm<sup>2</sup>.

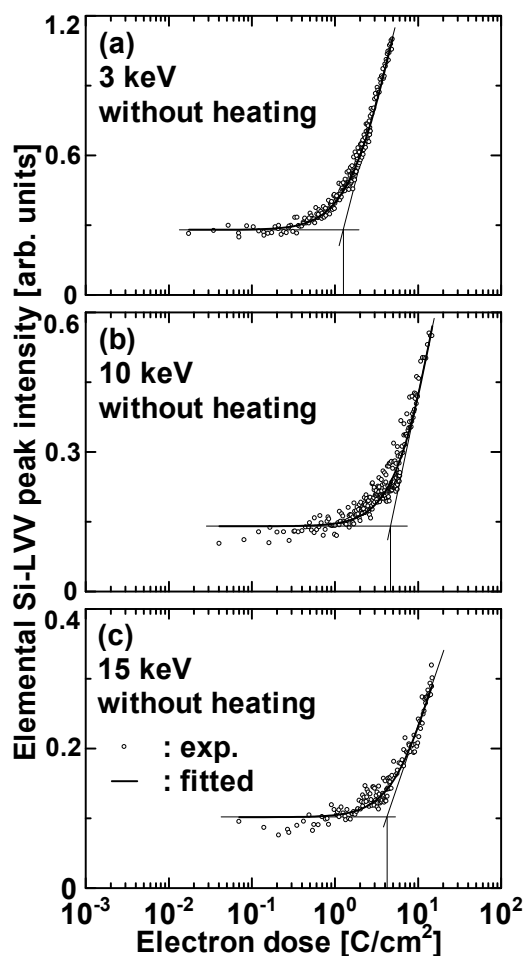
Figure 3 shows the variation in the intensity of the

elemental Si-LVV peak from the as-received SiO<sub>2</sub> film surface with the increase in the electron dose. In all primary energies, the decomposition of SiO<sub>2</sub> significantly proceeds above a certain dose. The value of this dose is dependent on the primary energy of electrons and clearly larger for the higher primary energy. These tendencies are the same as those reported previously [9-12].

Fig. 3. Changes in the intensity of the elemental Si-LVV peak from the as-received SiO<sub>2</sub> film surface, on which carbon contaminations exist. The primary energies of electrons are (a) 3, (b) 10, and (c) 15 keV. Open circles represent the experimental results. Solid lines labeled as “fitted” show the results of the fitting of Eq. (2) describing the two-step decomposition model to the experimental data. Thin solid lines are shown as a guide for eyes to display the onset of the curves.

In “Results and Discussion” the authors say “In addition, a comparison between Figs. 3 and 4 revealed that the dose, at which the speed of the decomposition of SiO<sub>2</sub> significantly increases, for the as-received SiO<sub>2</sub> film surface tends to be larger than that for the clean surface as confirmed from the onset position indicated by thin solid lines in Figs. 3 and 4.” By my eye sight, it seems to be the case for 3 keV, but difficult to distinguish for 10 keV and 15 keV. Is this my misunderstanding?

Yes. Your comment is correct. This is why the critical dose plotted in Fig. 6 shows almost the same values for with and without carbon contaminations at the primary energy of 15 keV. This comes from the fact that the elec-

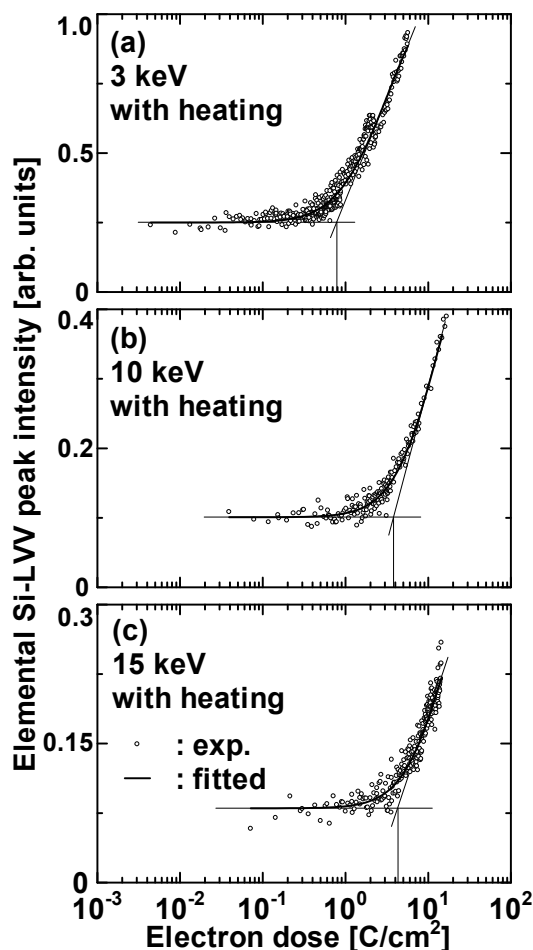
The change in the intensity of the elemental Si peak from the clean SiO<sub>2</sub> film surface with the increase in the electron dose is shown in Fig. 4. As observed for the as-received SiO<sub>2</sub> film surface in Fig. 3, the decomposition of SiO<sub>2</sub> slowly proceeds below a certain dose and becomes significant above that dose, which is larger for the higher primary energy. In addition, a comparison between Figs. 3 and 4 revealed that the dose, at which the rate of the decomposition of SiO<sub>2</sub> significantly increases, for the as-received SiO<sub>2</sub> film surface tends to be larger than that for the clean surface as confirmed from the onset position indicated by thin solid lines in Figs. 3 and 4, except for that at 15 keV, where no significant difference is observed. This result revealed that the electron-induced damage of SiO<sub>2</sub> is reduced by carbon contaminations on the SiO<sub>2</sub> surface.

Fig. 4. Changes in the intensity of the elemental Si-LVV peak from the clean SiO<sub>2</sub> film surface. The primary energies of electrons are (a) 3, (b) 10, and (c) 15 keV. Open circles represent the experimental results. Solid lines labeled as “fitted” show the results of the fitting of Eq. (2) describing the two-step decomposition model to the experimental data. Thin solid lines are shown as a guide for eyes to display the onset of the curves.
